| <b>Prüfbericht-Nr.:</b><br><i>Test report no.:</i> | <b>DE25I4ZS 001</b> | <b>Auftrags-Nr.:</b><br><i>Order no.:</i> | 30010 2513 | Seite 1 von 17<br>Page 1 of 17 |
| <b>Prüfgegenstand:</b><br><i>Test item:</i> | Surface coating (for caravan) | | | |
| <b>Bezeichnung / Typ-Nr.:</b><br><i>Identification / Type no.:</i> | HailGuard Pro R on Glass-fiber laminate [GFK] | | | |
| <b>Auftrags-Inhalt:</b><br><i>Order content:</i> | Hail Impact Test | | | |

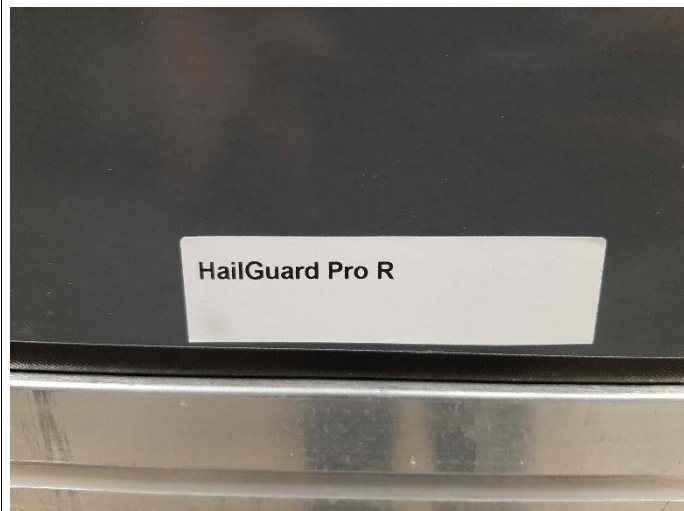
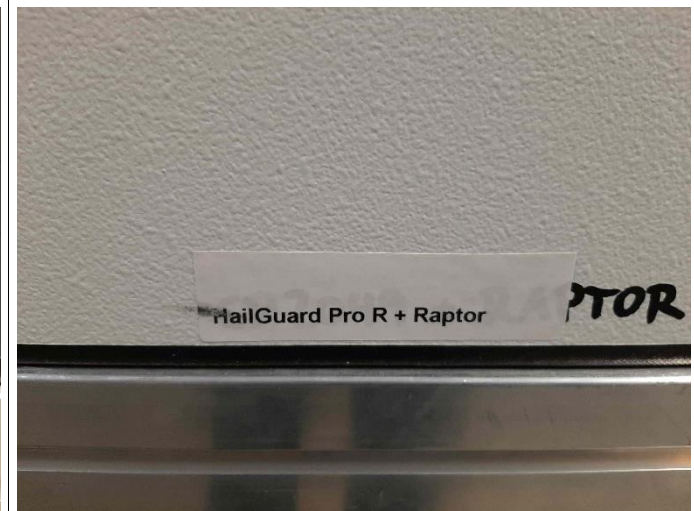
| Initial inspection – Marking - GFK | | Final inspection – marking – GFK-TC | |

| HV2025000041 | Several pre-marked surface damages | | |

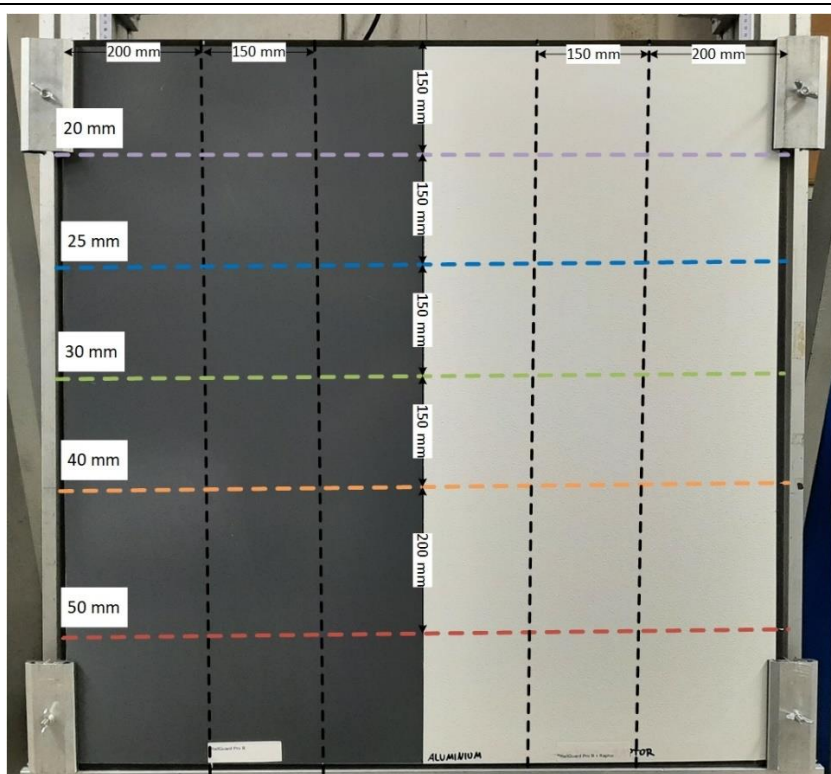
Description of impact location

Supplementary information: Cross-points of lines are impact locations with remarked ice diameter

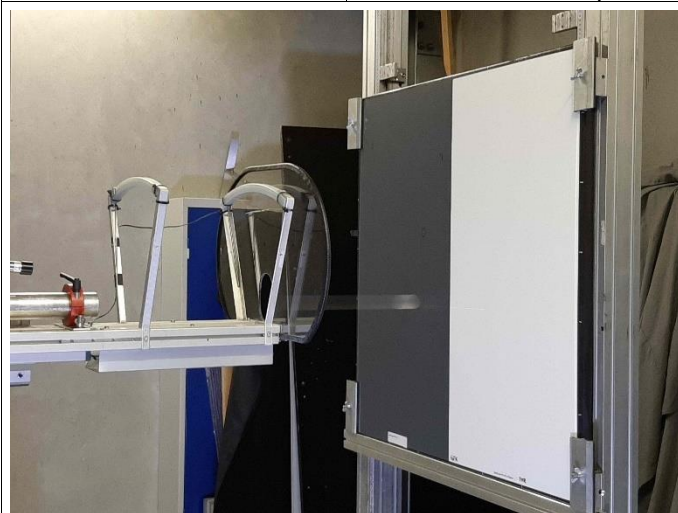
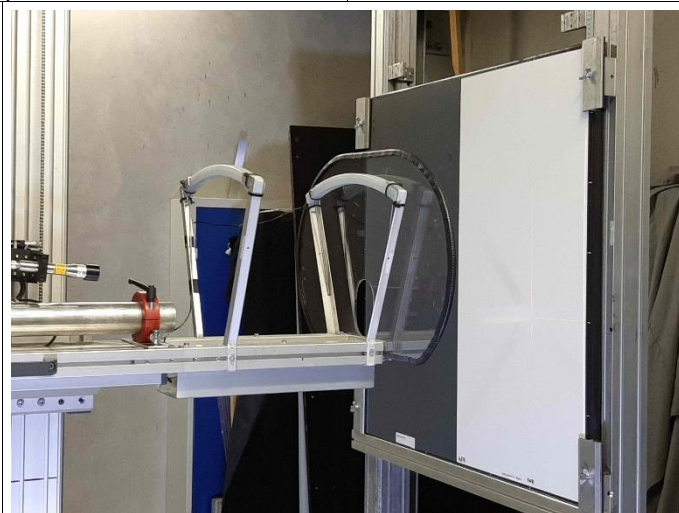
| GFK | Example of impact – 40 mm | GFK-TC |

| | Visual problems (distance; 5 m) | HW 4 <b>passed</b> ; <u>with 40 mm</u><br>NO cracks visible<br><b>NO dents visible</b><br>HW 5 <b>failed</b> ; <u>with 50 mm</u> | HW 4 <b>passed</b> ; <u>with 40 mm</u><br>NO cracks visible<br><b>NO dents visible</b><br>HW 5 <b>failed</b> ; <u>with 50 mm</u> | N/A* | |

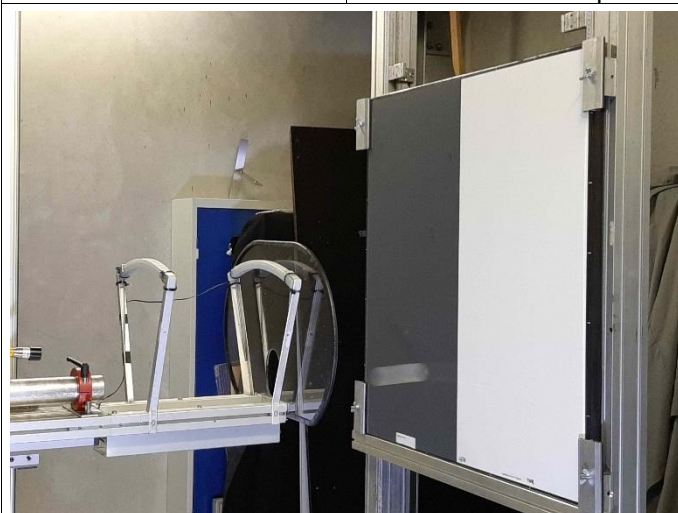
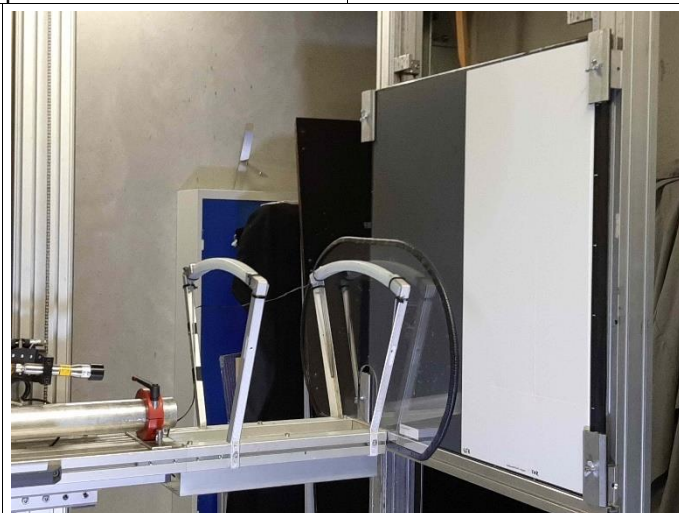
| GFK | Example of impact – 50 mm | GFK-TC |

| | Additional technical remark | <b>Generally water tight ;</b><br>Even if GFK-layer is broken, base coating is still water tight (up to <u>50 mm/HW5</u> ) | <b>Generally water tight ;</b><br>Even if GFK-layer is broken, complete coating is still water tight (up to <u>50 mm/HW5</u> ) | — | |

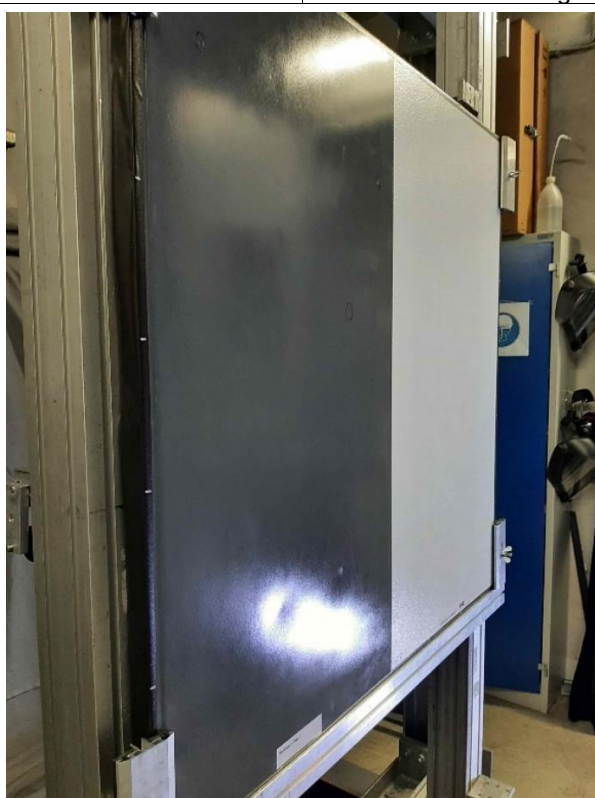
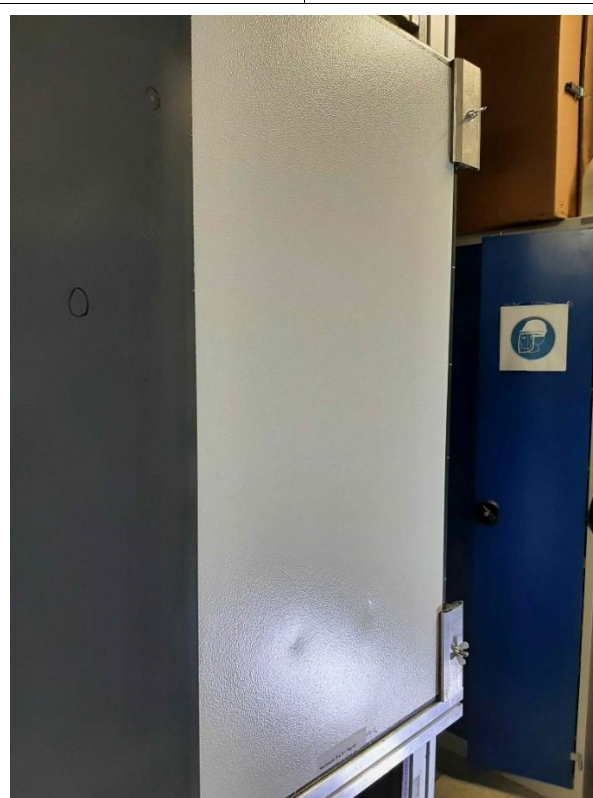
| GFK | Damage of impact – 20 mm | GFK-TC |

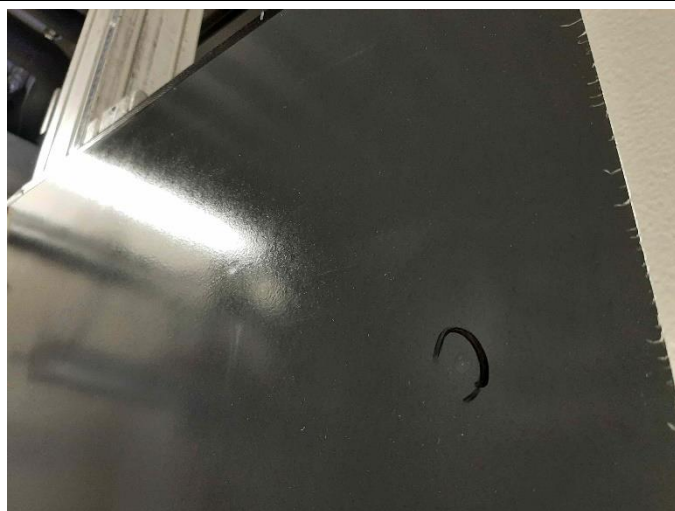
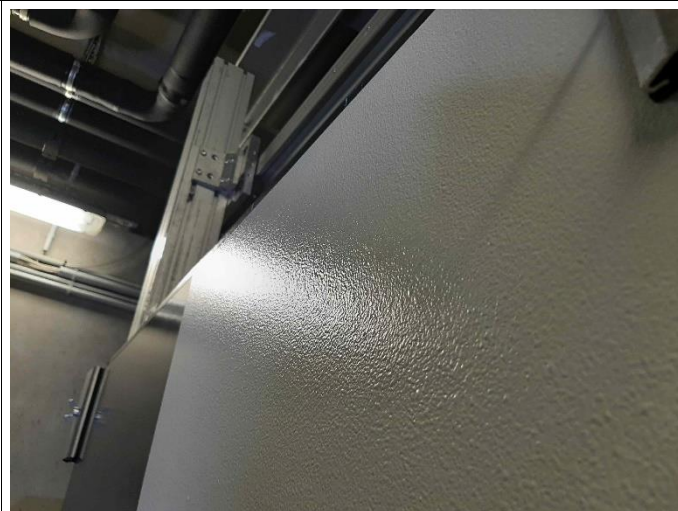
| GFK | Damage of impact – 20 mm | GFK-TC |

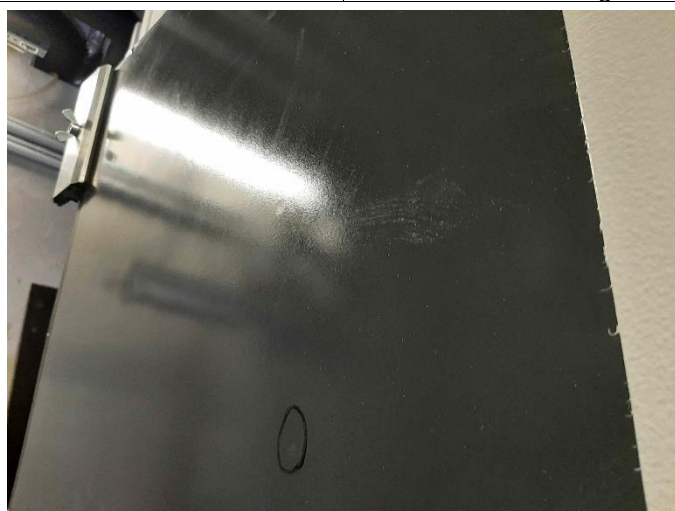
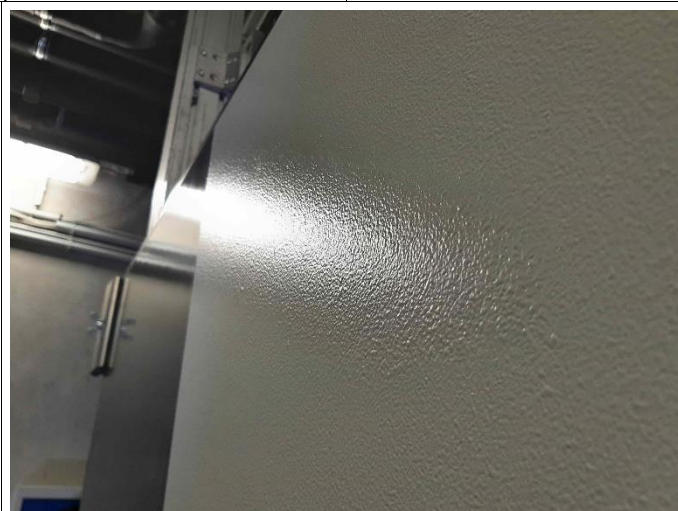
| GFK | Damage of impact – 25 mm | GFK-TC |

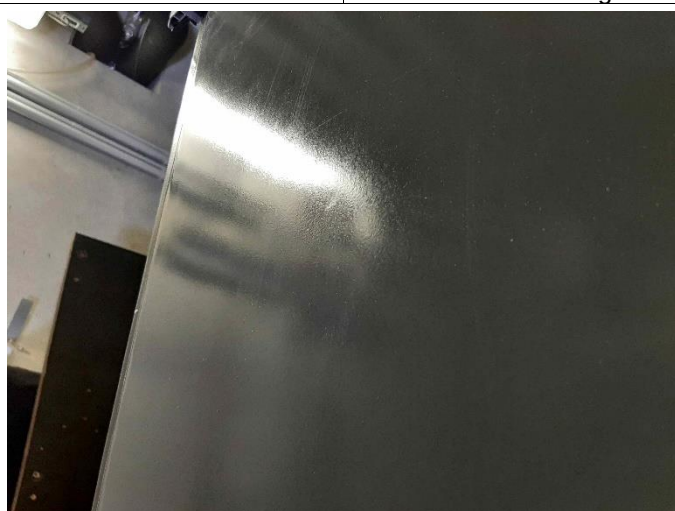
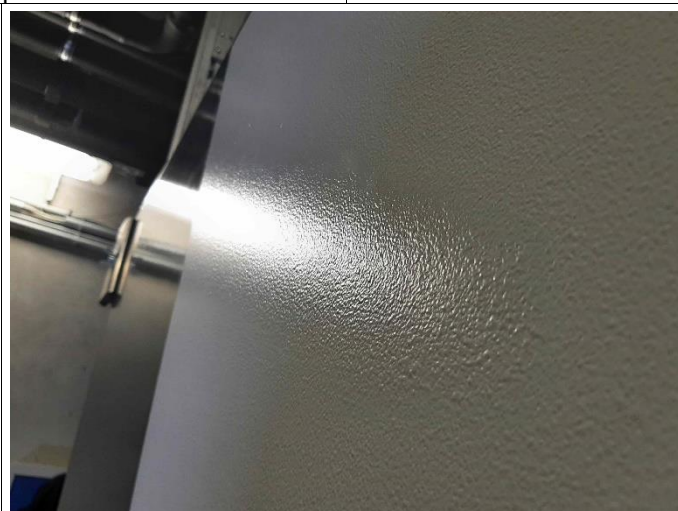
| GFK | Damage of impact – 30 mm | GFK-TC |

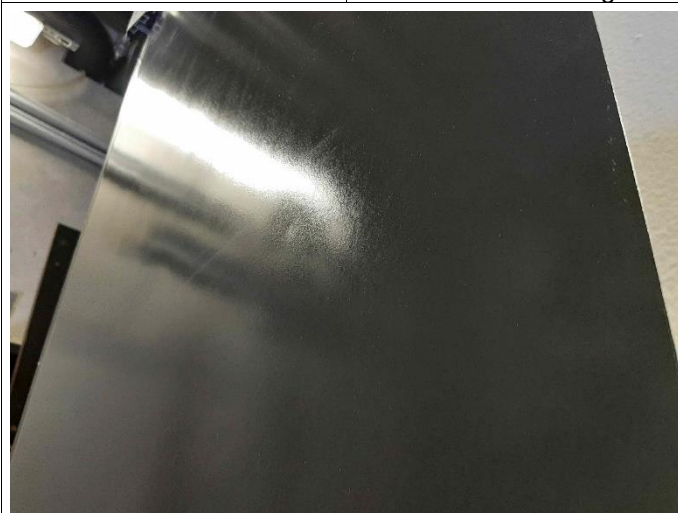
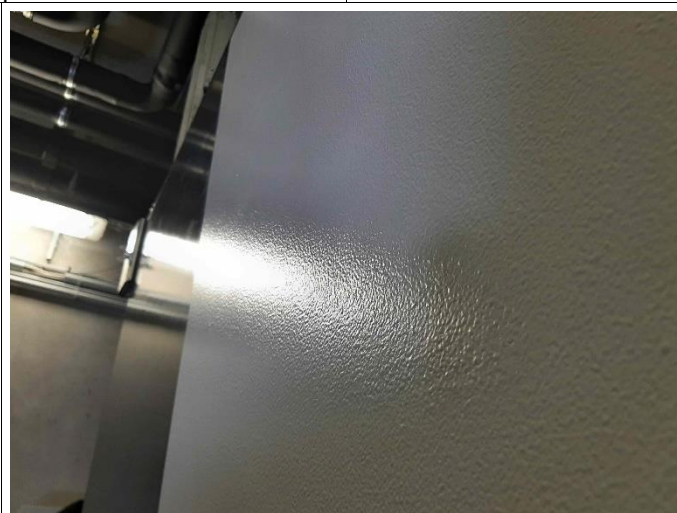
\*GFK-layer is broken, but coating is still intact and water tight; also at HW5/50 mm

| GFK | Damage of impact – 40 mm | GFK-TC |

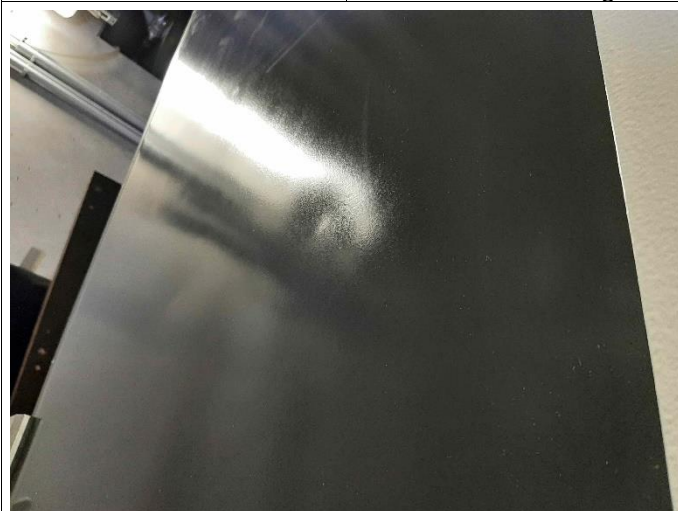
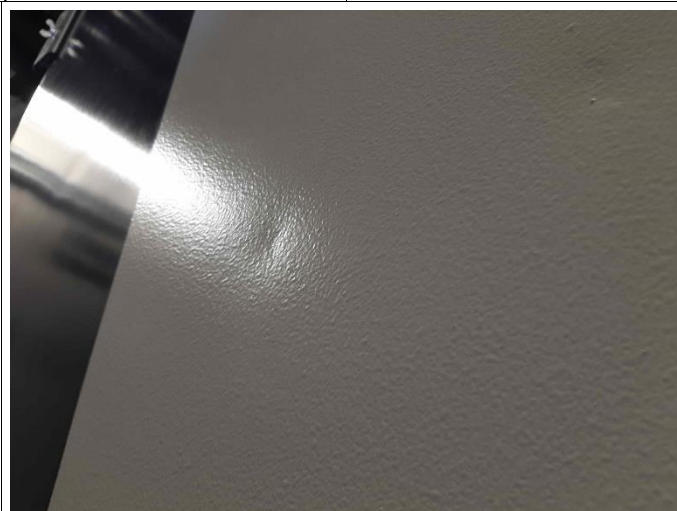
| GFK | Damage of impact – 50 mm | GFK-TC |

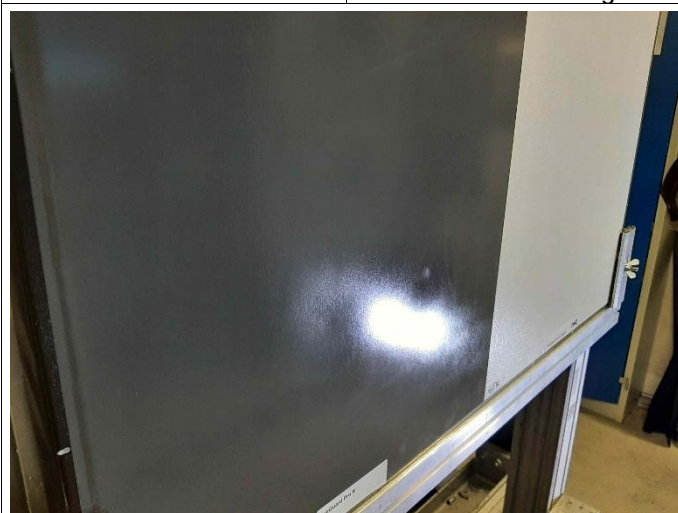
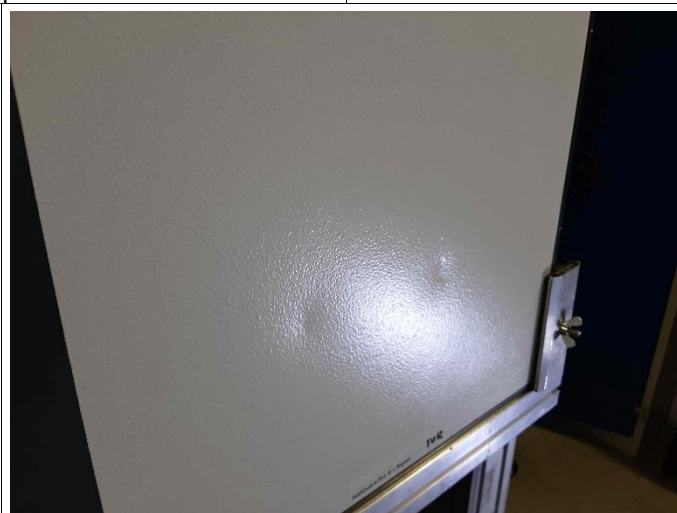
| GFK | Damage of impact – 50 mm | GFK-TC |

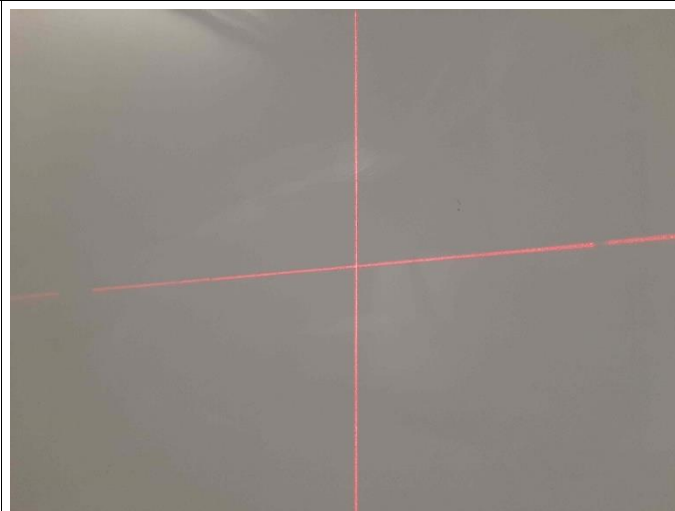
Comparable Damage of impact – 30 mm

Comparable impacts on un-coated GFK surface.
