| <b>Prüfbericht-Nr.:</b><br>Test report no.: | <b>DE25NEWI 002</b> | <b>Auftrags-Nr.:</b><br>Order no.: | 2125 1542 | Seite 1 von 15<br>Page 1 of 15 |
| <b>Prüfgegenstand:</b><br>Test item: | Surface coating (for caravan) | | | |
| <b>Bezeichnung / Typ-Nr.:</b><br>Identification / Type no.: | HailGuard Pro S | | | |
| <b>Auftrags-Inhalt:</b><br>Order content: | Hail Impact Test | | | |

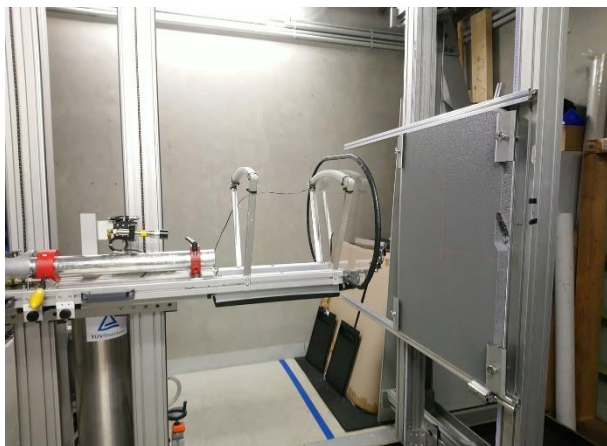
Set-up and mounting situation (example)

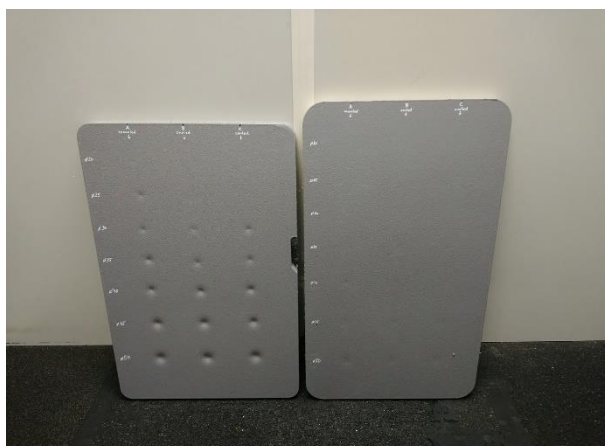
Final inspection – external – Alu vs. GFK (example)

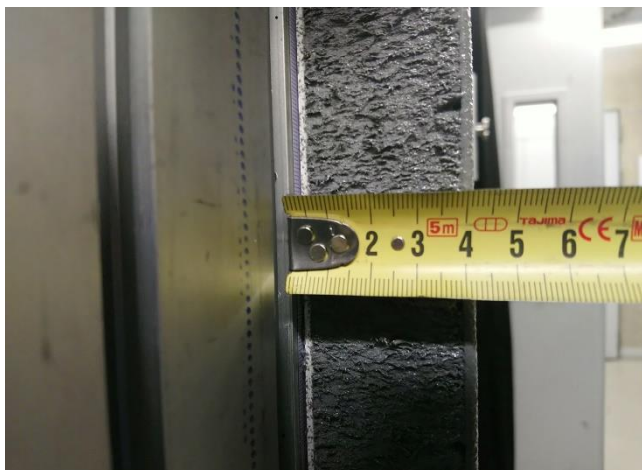
Example of thickness (Alu)

| | | Layer thickness [mm] | 1.5 |

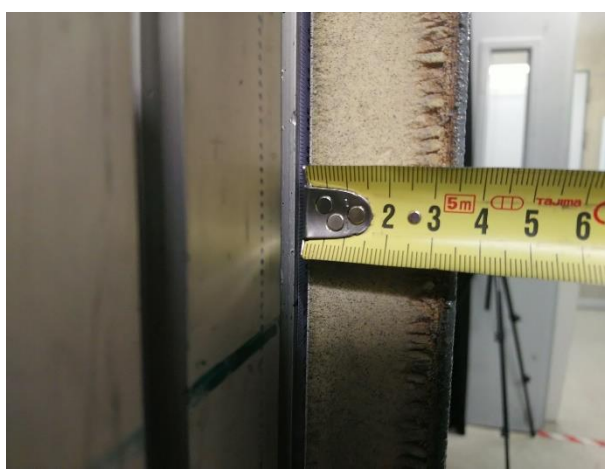
Example of thickness (GFK)

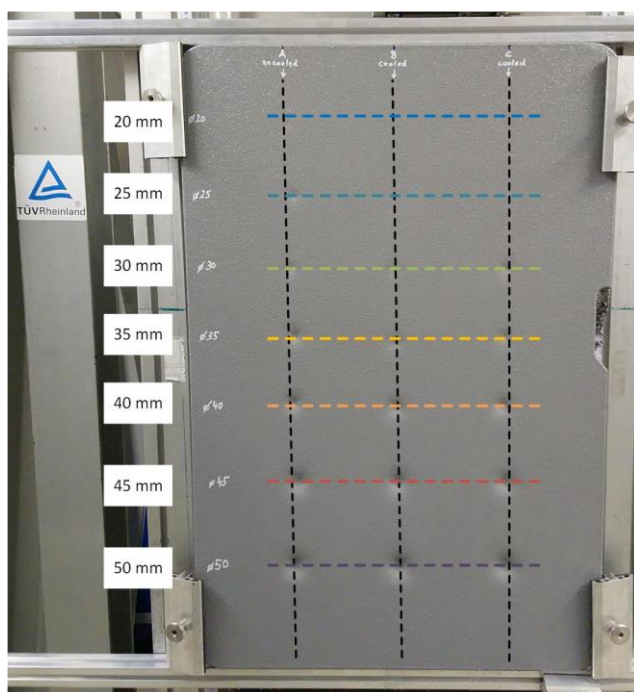
Description of impact location

Supplementary information: Cross-points of lines are impact locations with remarked ice diameter

| Diameter of ice ball [mm] | 20 | 25 | 30 | 35 | 40 | 45 | 50 |

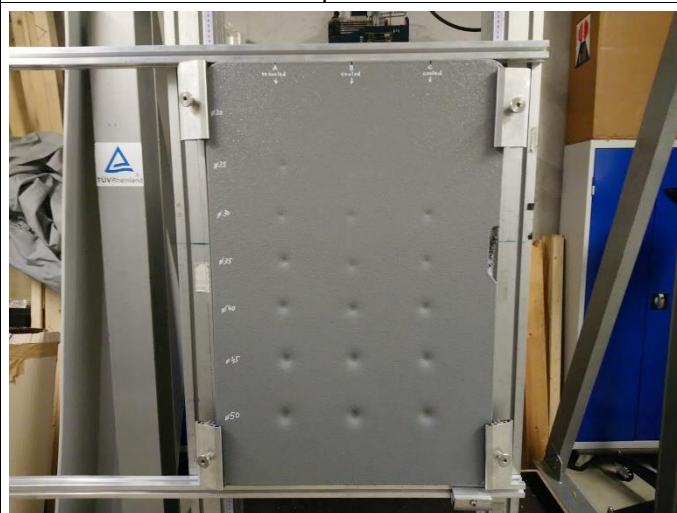
Final inspection - Alu

| HV2021000371<br>HV2021000372 | Technical problems | HW 2 <b>passed</b> ;<br><u>with 20 mm</u><br><br>NO cracks visible under use<br>of magnifier<br><br>NO structural damages detectable | HW 3 <b>passed</b> ;<br><u>with 30 mm</u><br><br>NO cracks visible under use<br>of magnifier<br><br>NO structural damages detectable | N/A* | |
| | Additional technical remark | Generally water tight ;<br>Dents and stretching of<br>aluminium sheet only<br>(up to <u>50 mm</u> ) | Generally water tight ;<br>Glass-fiber laminate<br>broken at <u>&gt;35 mm</u><br><br><b>Water tightness given<br/>by coating only</b> | — | |

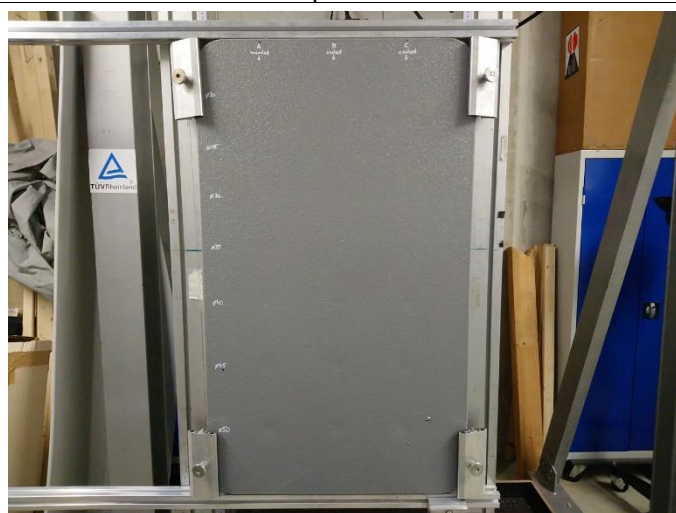
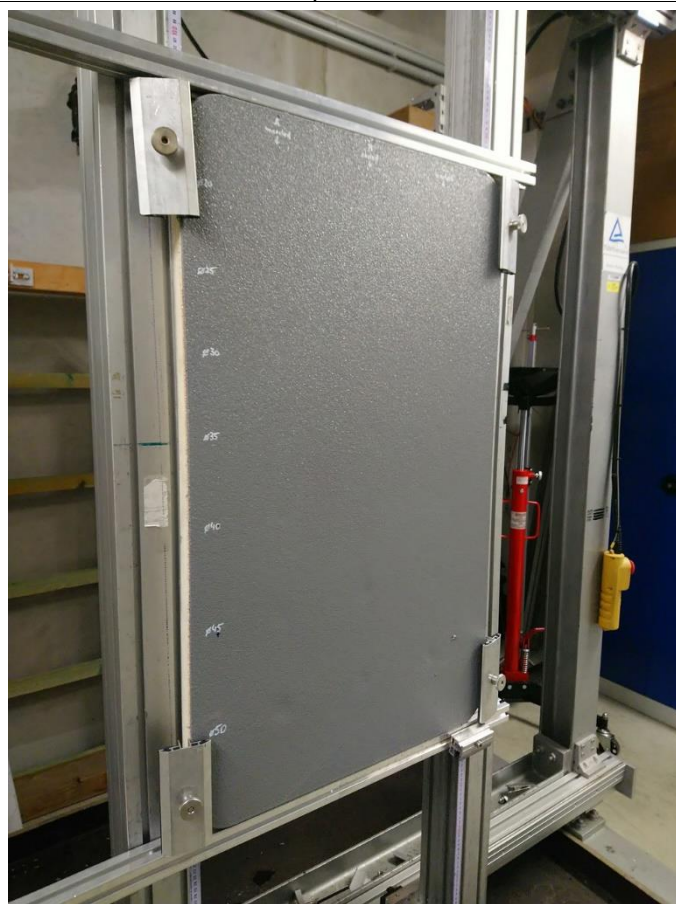
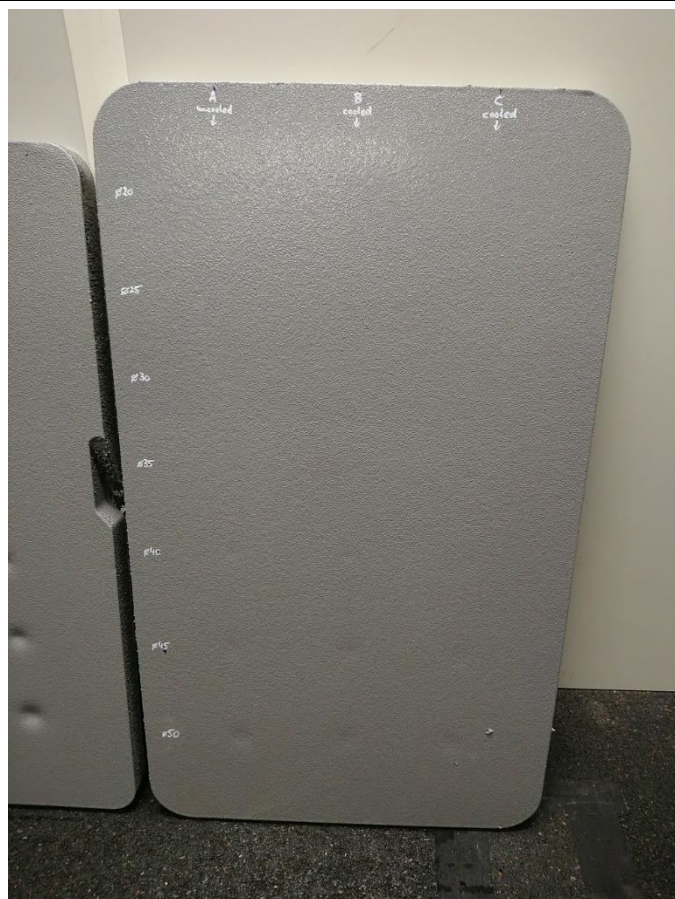
Final inspection - GFK

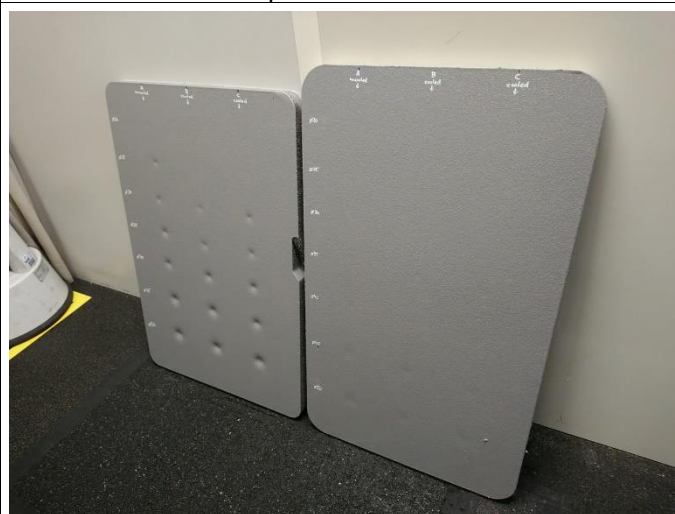
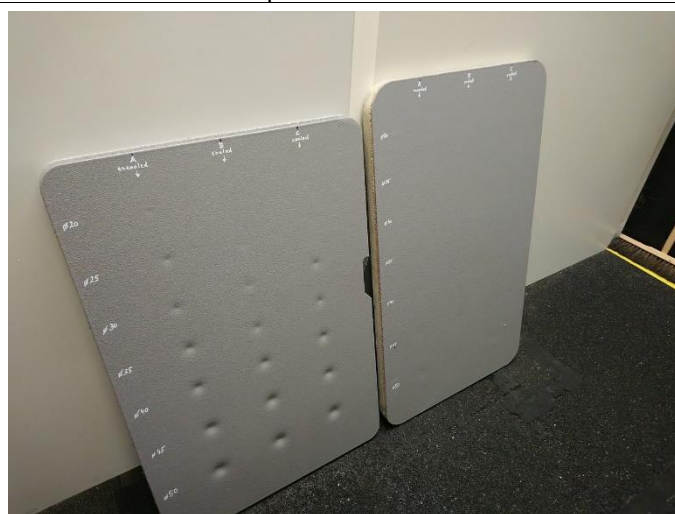
Final inspection – Alu vs. GFK

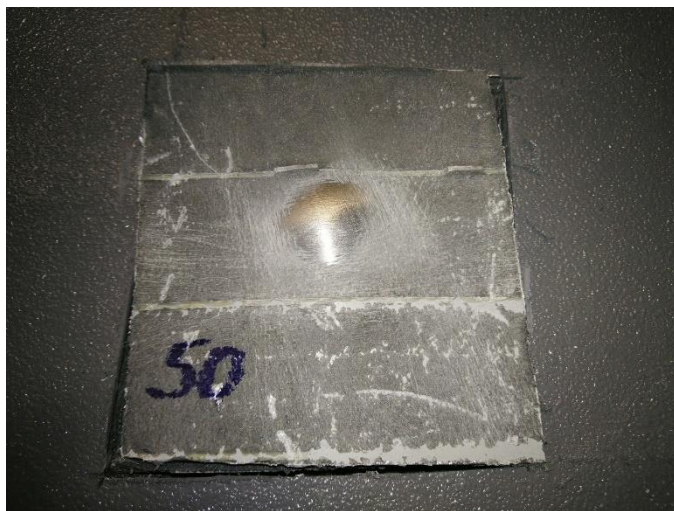
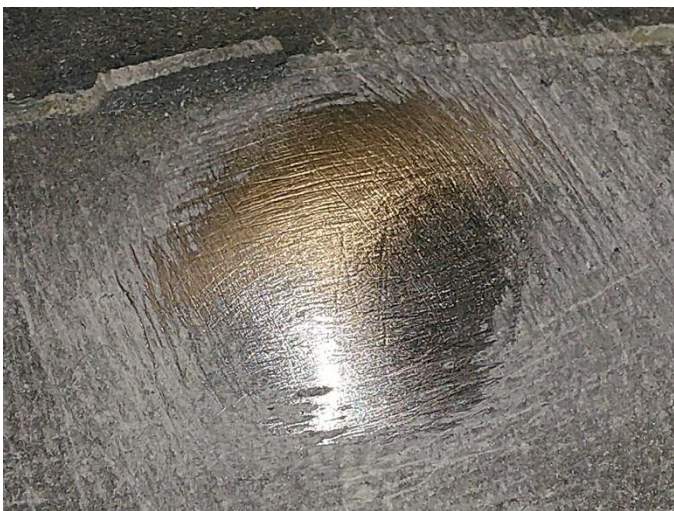
| Absatz<br>Clause | Anforderungen - Prüfungen /<br>Requirements - Tests | Messergebnisse – Bemerkungen/<br>Measuring results - Remarks | Ergebnis<br>Result |
|---|---|---|---|
| Final inspection - Alu | | Final inspection – Alu [NO cracks] | |

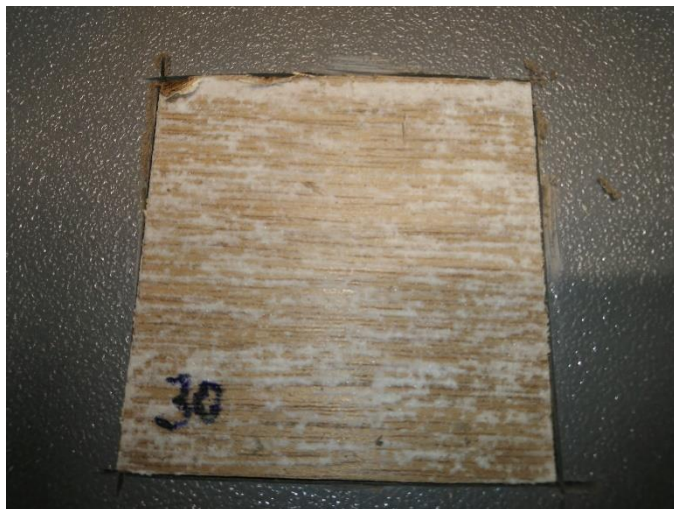
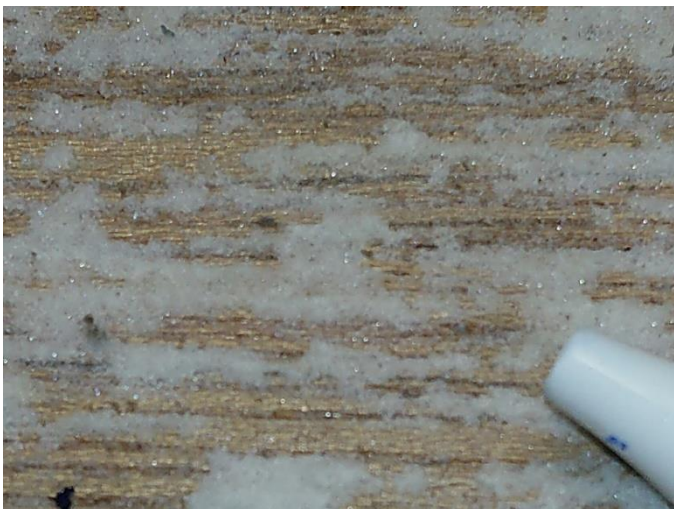
| Absatz<br>Clause | Anforderungen - Prüfungen /<br>Requirements - Tests | Messergebnisse – Bemerkungen/<br>Measuring results - Remarks | Ergebnis<br>Result |
|---|---|---|---|
| Final inspection - GFK | | Final inspection – GFK [NO cracks] | |

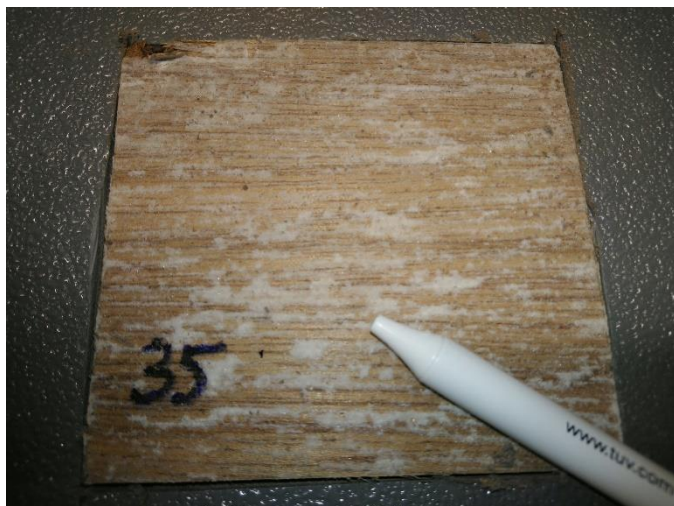
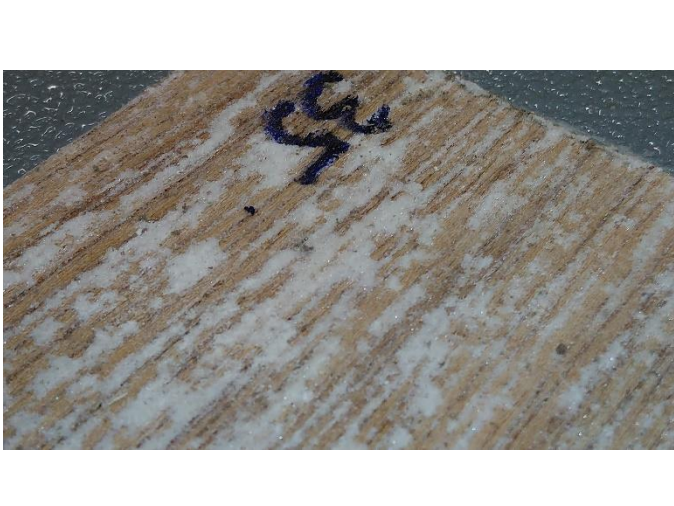
| Absatz<br>Clause | Anforderungen - Prüfungen /<br>Requirements - Tests | Messergebnisse – Bemerkungen/<br>Measuring results - Remarks | Ergebnis<br>Result |
|---|---|---|---|
| Final inspection - GFK | | Final inspection – GFK [with cracks] | |

\*glass-fiber laminate is broken (internally), but system is still water tight by coating

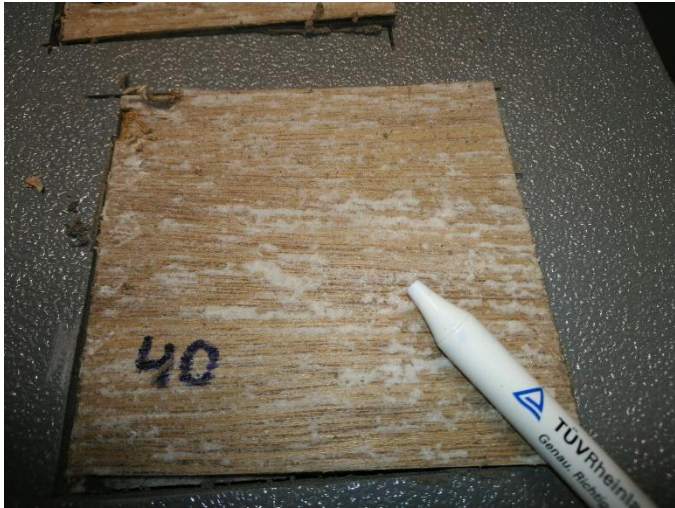
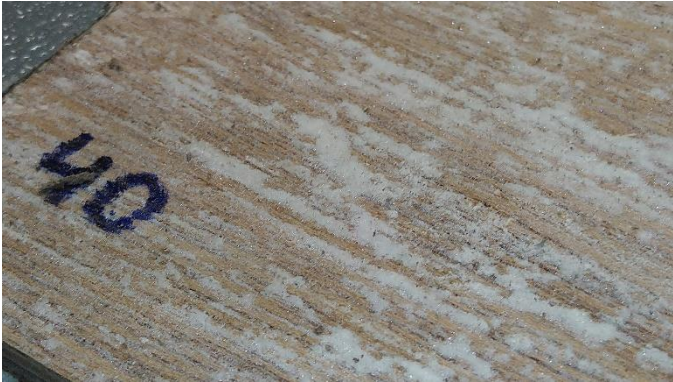
| Absatz<br>Clause | Anforderungen - Prüfungen /<br>Requirements - Tests | Messergebnisse – Bemerkungen/<br>Measuring results - Remarks | Ergebnis<br>Result |
|---|---|---|---|
| Final inspection - GFK | | Final inspection – GFK [with cracks] | |

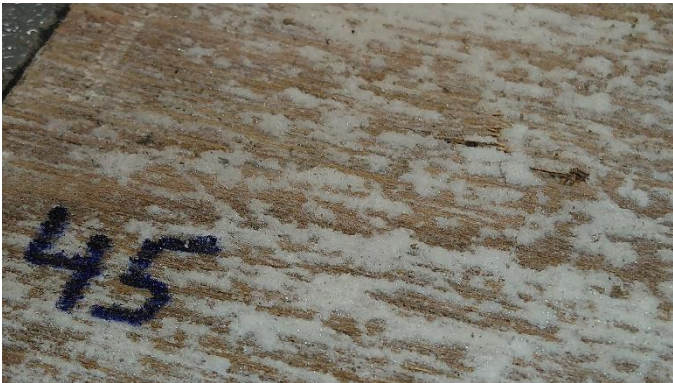
| Absatz<br>Clause | Anforderungen - Prüfungen /<br>Requirements - Tests | Messergebnisse – Bemerkungen/<br>Measuring results - Remarks | Ergebnis<br>Result |
|---|---|---|---|
| Final inspection - GFK | | Final inspection – GFK [with cracks] | |

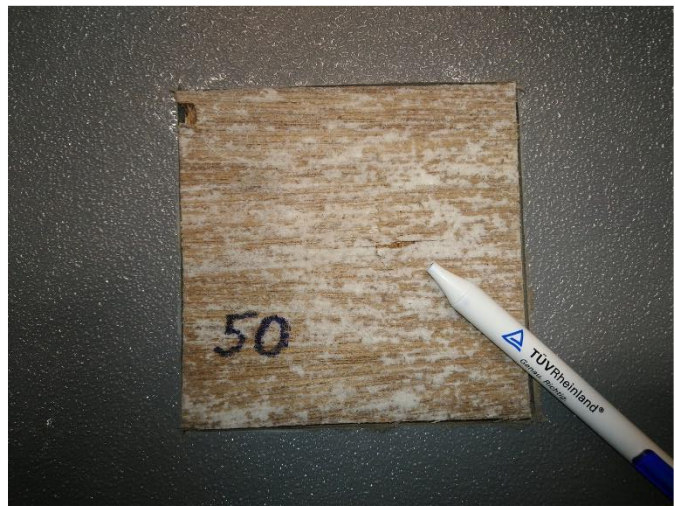
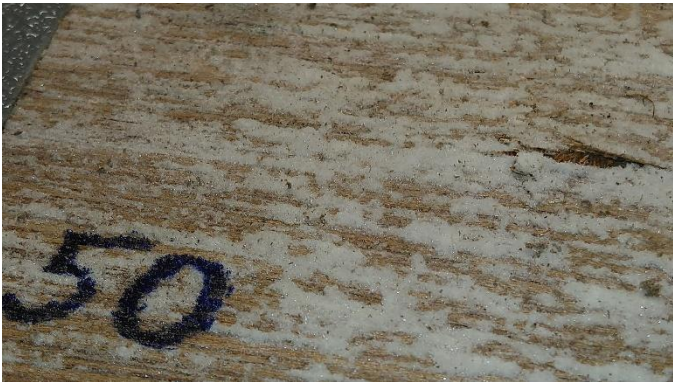
| Absatz<br>Clause | Anforderungen - Prüfungen /<br>Requirements - Tests | Messergebnisse – Bemerkungen/<br>Measuring results - Remarks | Ergebnis<br>Result |
|---|---|---|---|
| Final inspection - GFK | | Final inspection – GFK [with cracks] | |
